# **Project Spotlight: Spring Meadows Club House**

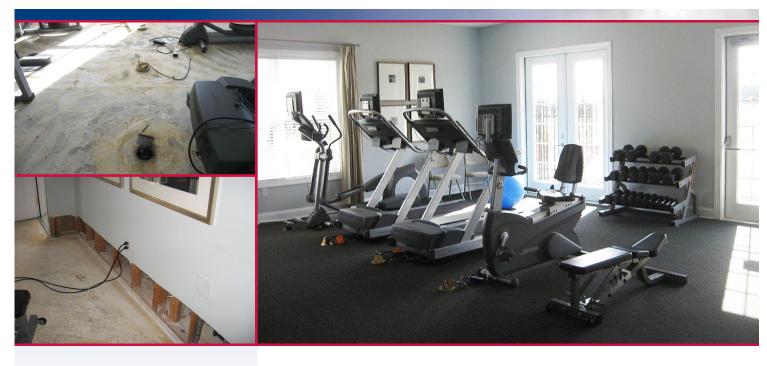
**Left Photo (Top):** Flooding damaged the floor of the club, threatening to harm expensive exercise equipment. **(Bottom):** Flooring and a small portion of the wall board needed to be removed and replaced.

**Right Photo:** Finished club house exercise room which included new flooring, drywall, baseboards and paint.

The club house building of Spring Meadows includes an exercise room, dance room, billiard room and kitchen. When the pipe broke, approximately 2 inches of water flooded the entire building, damaging hardwood flooring and carpeting, baseboards and drywall, and threatening expensive exercise equipment.

After cleanup, the team at ACCORD Restoration was called in to quickly begin the restoration process. The damaged flooring, baseboards and lower drywall were removed. New hardwood flooring, carpet and drywall were installed, and the team replaced baseboards and painted the entire building.
