Project Spotlight: St. Timothy's School - Water Damage

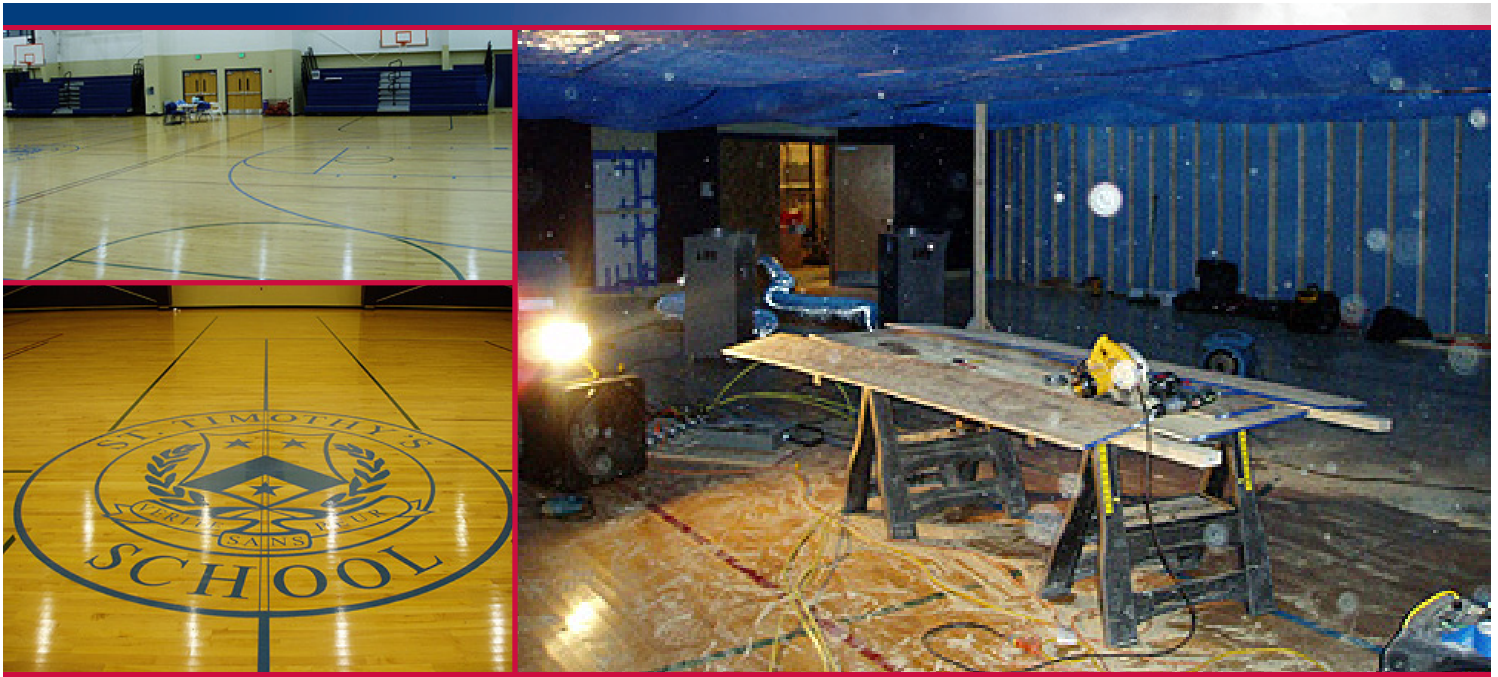
Left Photo (Top): Upon completion of the restoration project, the entire gym floor was sanded and re-finished.

Right Photo: ACCORD contained the mold while working on restoring the damaged area.

A blown pressure valve in the utility room caused water to leak onto the gym floor at St. Timothy's School in Stevenson, Maryland.

Two serious problems had occurred, the gym floor had become warped and cracked and mold had built up around a quarter of the floor area.

The first thing on the agenda was to contain the mold. For this, a containment area had to be built and an industrial hygienist was brought in to evaluate the mold build-up. The hygienist gave ACCORD Restoration the protocol needed to properly remove the mold and get the entire area cleaned, sterilized and ready for use. Once the contaminated floor area was properly cleaned, ACCORD Restoration was able to verify that the mold was completely gone and moved on to the next step of drying the floor with professional dry-out systems. ACCORD Restoration completely removed and replaced the gym floor that was in the mold containment area and as a finishing touch, the entire gym floor was sanded, re-finished and re-lined. Throughout the entire restoration process, ACCORD Restoration had coordinated all aspects of the job, including laborers, sub-contractors, hygienists and insurance adjusters.

With this project, ACCORD Restoration mitigated significant additional "loss of use" time and additional cost of repairs. The isolation and containment of the mold allowed for continued occupancy and safety and a significant portion of the basketball court was saved from replacement due to the speed of mitigation and strategic drying of the floating floor system.
